***FAULT RUPTURE HAZARD INVESTIGATION, CASA BLANCA  
RANCH PROJECT, NORTH OF OAK GLEN ROAD, CITY OF  
YUCAIPA, SAN BERNARDINO COUNTY, CALIFORNIA***

***MERIDIAN LAND DEVELOPMENT***

***JUNE 27, 2013  
J.N. 12-291***

**Subject: Fault Rupture Hazard Investigation, Casa Blanca Ranch Project, North of Oak Glen Road, City of Yucaipa, San Bernardino County, California**

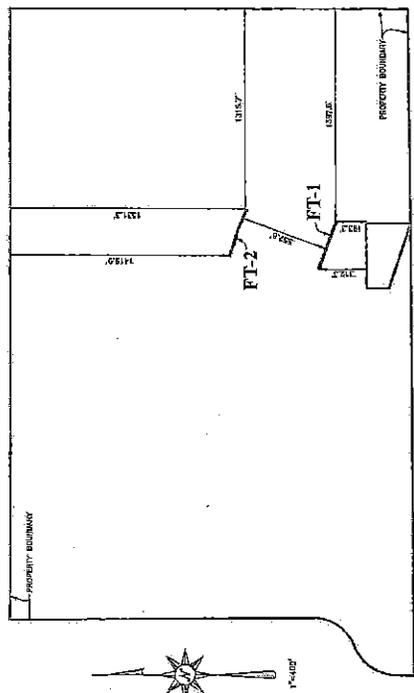
**Figure 3**

After review of pertinent literature and interpretation of aerial photographs and topographic maps, two exploratory trenches were strategically placed across a suspected escarpment mapped as two relative short fault segments (Matti, et. al., 2003). A small westward flowing incised drainage channel bisects the two mapped escarpments. The total trench length totaled about 655 linear feet with depths up to approximately 10 to 10.5 feet below existing grades. A five foot wide, mid-height bench was established within both sides of each trench. Trench T-1 is approximately 330 feet long and was placed across the southern mapped escarpment approximately 200 to 300 feet north of the existing water reservoir. Trench T-2 is approximately 325 feet long and was placed across the northern mapped escarpment approximately 550 feet north of T-1. The trenches were oriented approximately perpendicular to the general mapped escarpment and topographic break in the area. The trench locations were surveyed by Hess Development Inc. during the course of our fieldwork as shown on Figure 3.

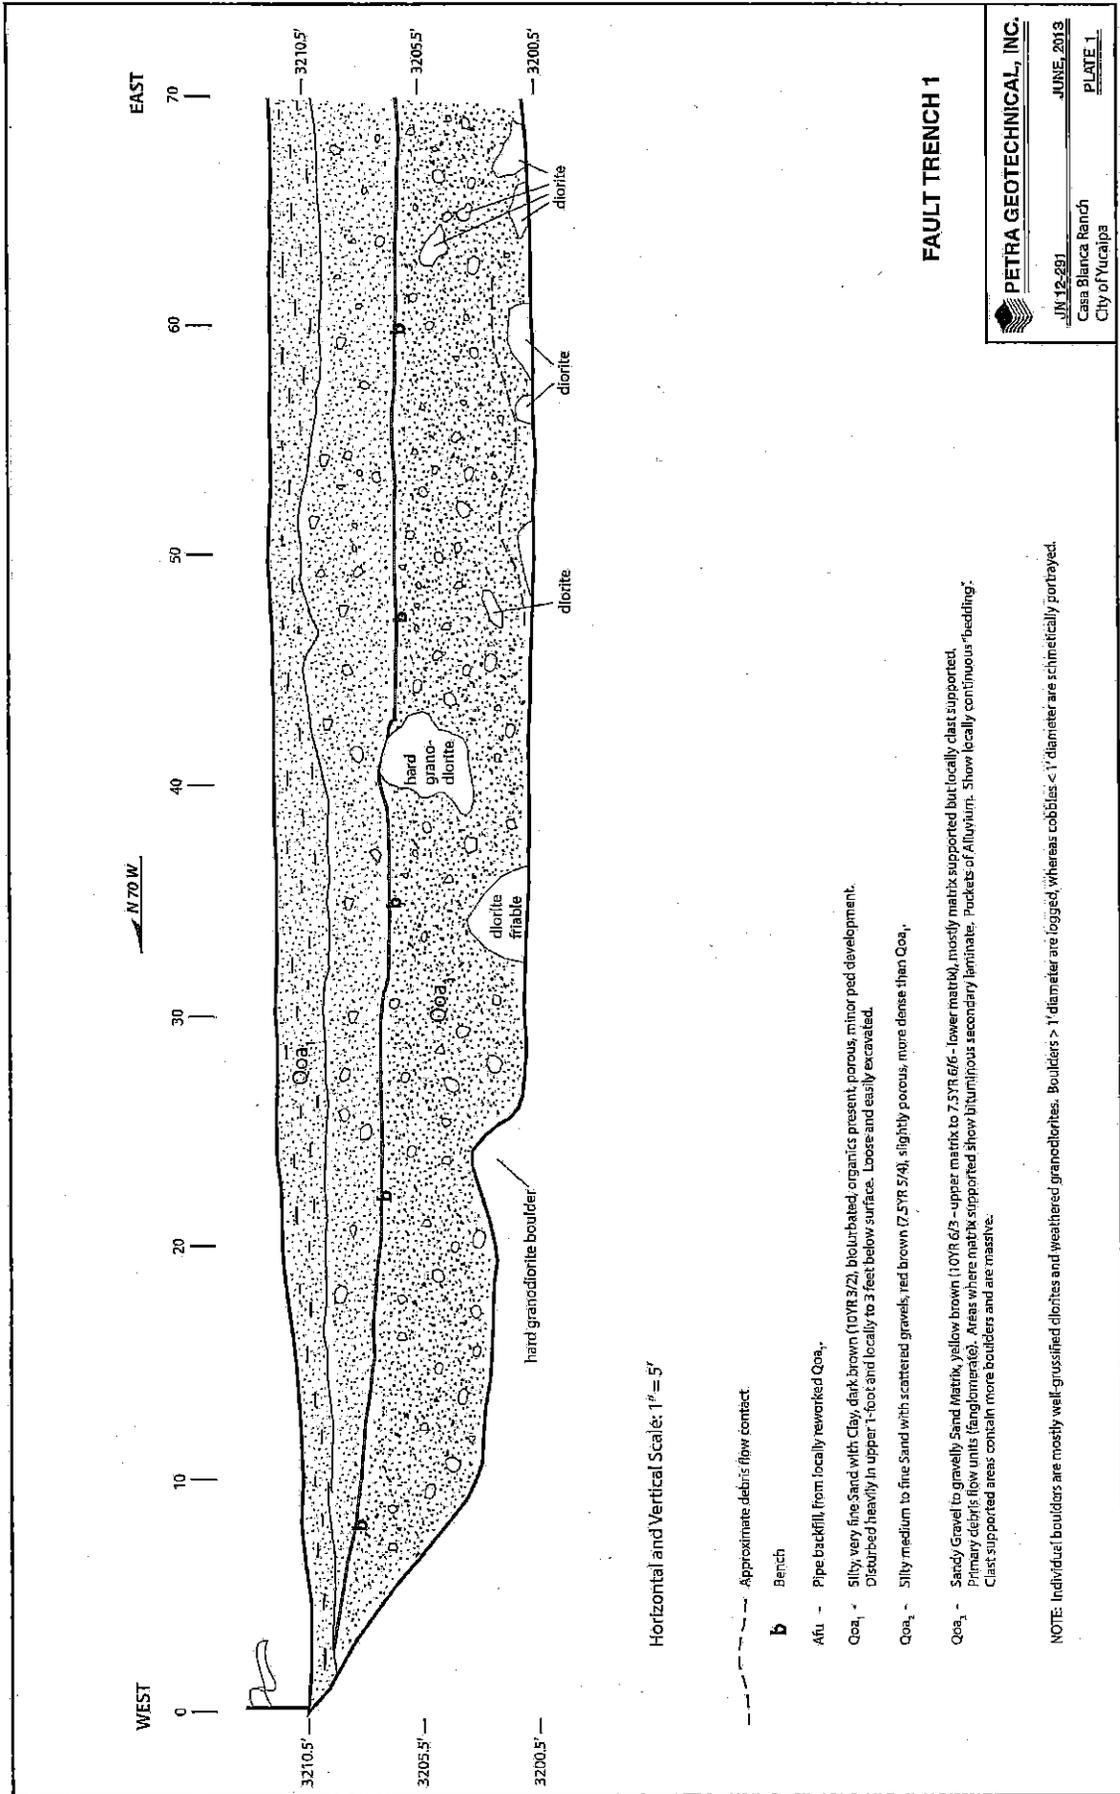
**FAULT TRENCH 1**

Based on trench exposures and as documented on the logs (Plates 1 through 8), the site is underlain by three main units of older alluvium and/or alluvial fan deposits; however the lower units (Qoa<sub>2</sub> and

The uppermost unit (Qoa<sub>1</sub>) mantles the site with depths ranging from approximately 1.5 to 4 feet, and consists of a cumulic soil horizon characterized by dark brown to dark grayish brown (10 YR 3/2 to 5/4) silty fine sands with clay and abundant organic accumulations. This soil horizon has been highly disturbed in the upper 1 to 2 feet by recent and historical tilling. A cumulic soil horizon forms by slow incremental deposition that approximates rate of soil development and is typically structureless and highly bioturbated as was observed within the trench exposures. Minor pedogenic development was also observed within this surficial unit indicating an early to mid-Holocene soil development profile (Kenney, 2013). Also documented on the trench logs is a minor amount of artificial fill related to the establishing the access ramps into the trenches and a buried concrete drainage pipe encountered in T-1. This unit was continuous and unbroken across the fault trench exposure, although it thickened slightly near the center of the trench.

Unit Qoa<sub>2</sub> which directly underlies Qoa<sub>1</sub> in the eastern half of each trench (the unit terminates near Station 150 in both trenches) consists of fine-grained alluvial fan type deposits that is considerably coarser grained than Qoa<sub>1</sub>, fine to medium sands with silt and scattered gravels, that was also friable and observed as brown to reddish brown (7.5 YR 3/3 to 5/4). This unit is generally massive, lacked any notable cobble or boulder inclusions and rested uncomfortably with the overlying Qoa<sub>1</sub> and underlying Qoa<sub>3</sub> units. This unit was also continuous and unbroken across the eastern half of the fault trench exposures and based on its stratigraphic relationship and degree of weathering is considered late Pleistocene in age (Kenney, 2013).

Unit Qoa<sub>3</sub> is the lowermost major member from our fault trench exposures and generally consists of gravelly sand to sandy gravel matrix within a cobble and boulder rich debris flow type deposits. The matrix is generally reddish yellow, yellowish brown to brownish yellow (7.5 YR 6/6, 10 YR 6/8 and 10 YR 3/6). The cobble and boulder component are most typically very strongly gneissified diorites with minor accumulations of weathered granodiorites and trace amounts of schist. The boulder clasts exposed reached dimensions up to 6 feet in diameter but were more commonly on the order of 2 to 3 feet in diameter. Faint relic bedding could be occasionally traced into the bottom of the trench identifying individual debris flow contacts which appear to be slightly tilted to the east at a very low angle. Based on

the high degree of weathering in this unit, the age of these sediments could be conservatively stated as 50,000 years. This unit was also continuous and unbroken across the fault trench exposures.

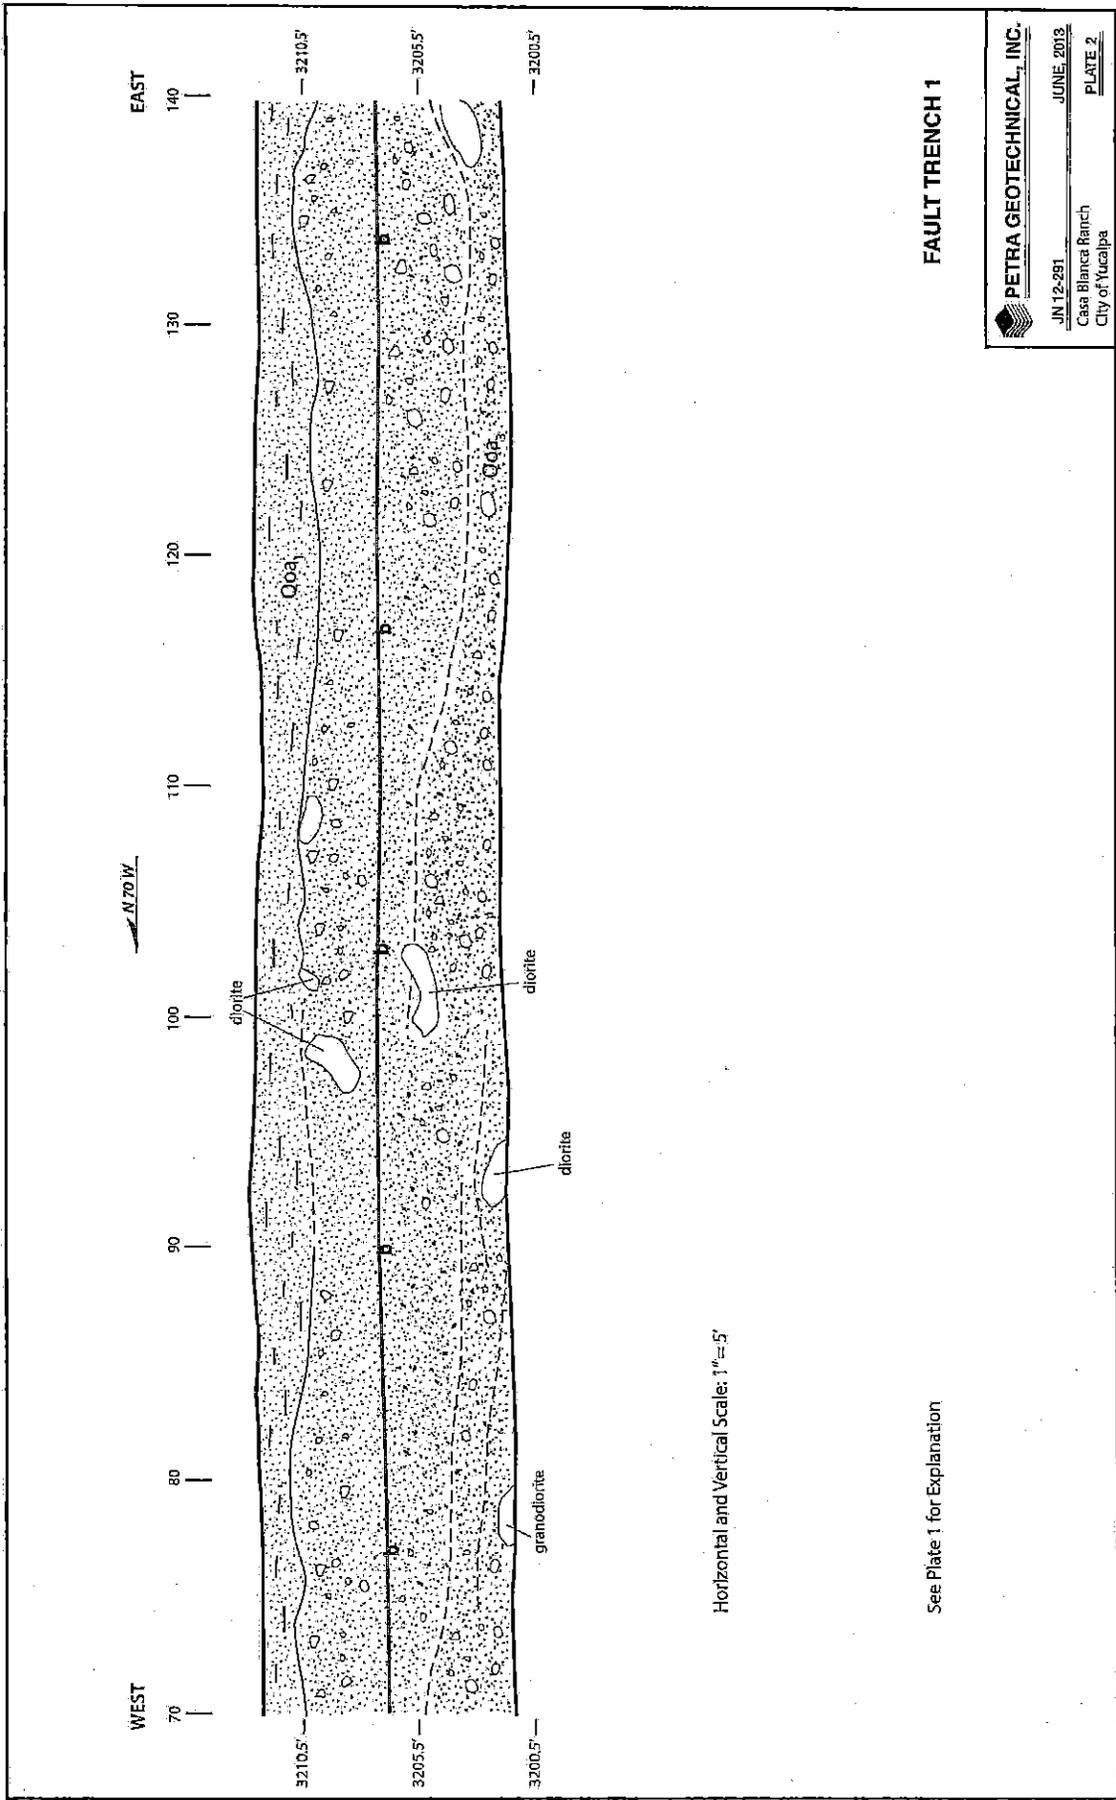
**PETRA GEOTECHNICAL, INC.**  
 JUN 12-291      JUNE, 2013  
 Casa Blanca Ranch      PLATE 2  
 City of Yucalpa

The disappearance of unit Qoa<sub>2</sub> near the center of the trenches, which coincides closely with the escarpment trace, and the relationship of the exposed geology has led us to postulate that the finer grained Qoa<sub>2</sub> materials were considerable more erodible than the underlying more erosion resistant boulder-rich debris flow type deposits of unit Qoa<sub>3</sub> and that differential weathering and fluvial processes (i.e. inset drainages) across the abandoned terrace created the localized topographic break. This could be easily interpreted as the appearance of a downdropped block due to tectonic movement on a normal fault based on surface field mapping or aerial photo interpretation. The thickening of the younger unit Qoa<sub>2</sub> near Station 180 in the trenches is also nearly in-line with the axial drainages leading to the existing incised westerly-trending channel bisecting the two mapped escarpments.
