Cultural Resources Inventory and Evaluation For the Casa Blanca Specific Plan Yucaipa, San Bernardino County, California

September 2015

Casa Blanca Ranch (Site CB-001)

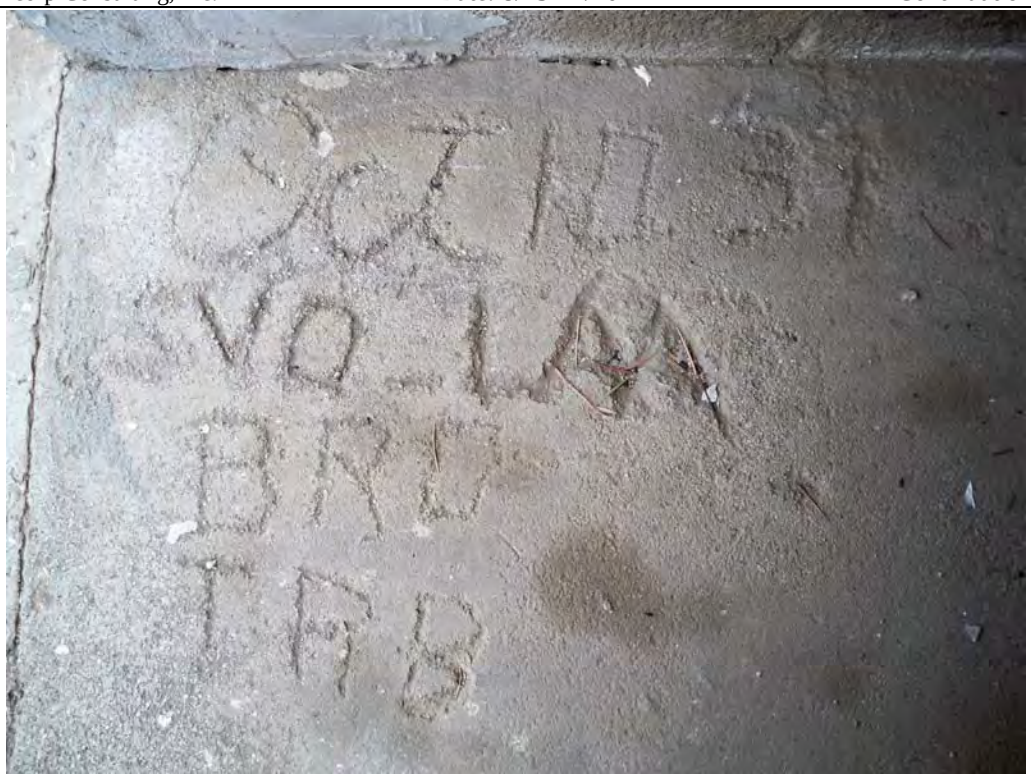
"Oct 10, '37", "SVO", "LAA", "BRO", "TRB" inscribed in floor of garage (Feature 2). View to north, 8/17/2012.

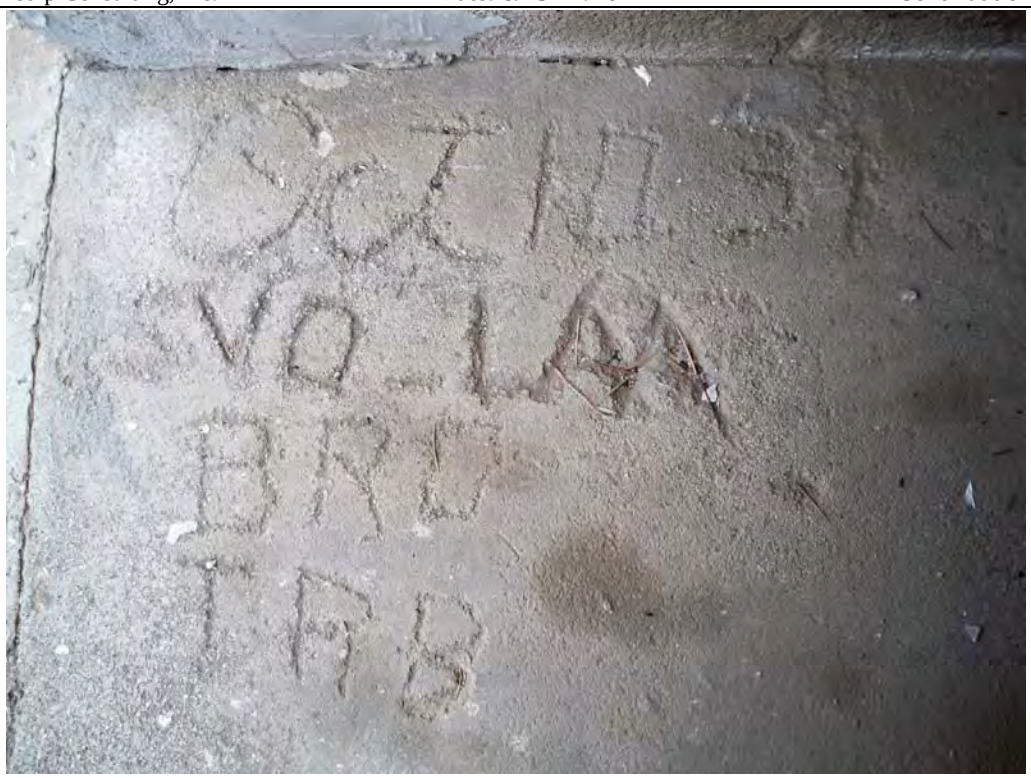
"Oct 10, '37", "SVO", "LAA", "BRO", "TRB" inscribed in floor of garage (Feature 2). View to north, 8/17/2012.
